# Manhole Inspection Summary

Manhole # S27A1\_011MH

Insp Date: **4/22/08 11:04 AM**

**Location** Address: **2119 ANNAPOLIS RD.**

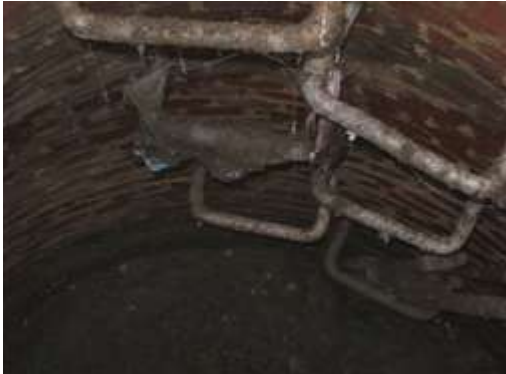
Defect 3

Infiltration: ☐ None ☐ Joint ☐ Cracks ☐ Mortar ☐ Roots ☒ Wall

**Surcharge** ☒ Evidence Of Surcharge Depth: **5** (ft.) ☐ Active Surcharge Present

EVIDENCE OF SURCHARGE ON STEP  
AND EVIDENCE OF BARREL  
INFILTRATION

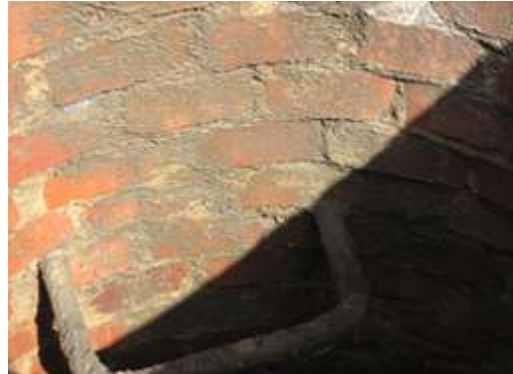
Defect 2

Infiltration: ☐ None ☐ Joint ☐ Cracks ☐ Mortar ☐ Roots ☒ Wall

EVIDENCE OF CORBEL INFILTRATION

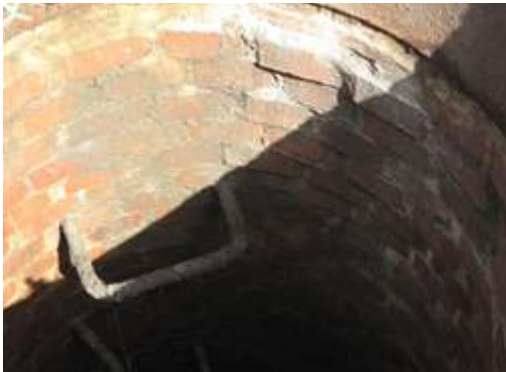
Defect 1

Infiltration: ☐ None ☐ Joint ☐ Cracks ☒ Mortar ☐ Roots ☐ Wall

EVIDENCE OF CHIMNEY  
INFILTRATION

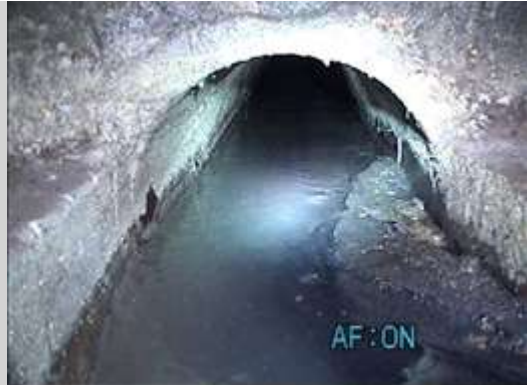
12 O'Clock Outflow

12 in. Circular Gravity Sewer  
Pipe Out @ 12 O'Clock

Infiltration: **None** Pipe Seal Cond: **Sound**

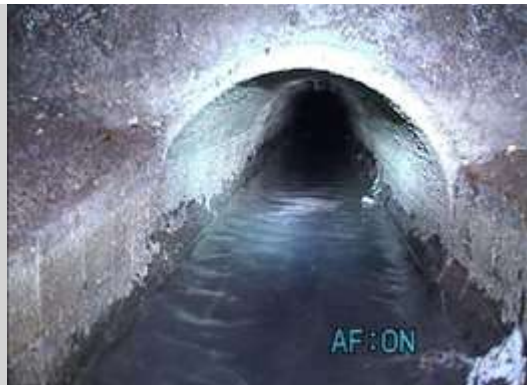
3 O'Clock Inflow

12 in. Circular Gravity Sewer  
Pipe In @ 3 O'Clock

Infiltration: **None** Pipe Seal Cond: **Sound**
